# Sucker Rod Failure Locations and Inspection Zones

Field inspection map for rod body, forged ends, threaded connections and couplings

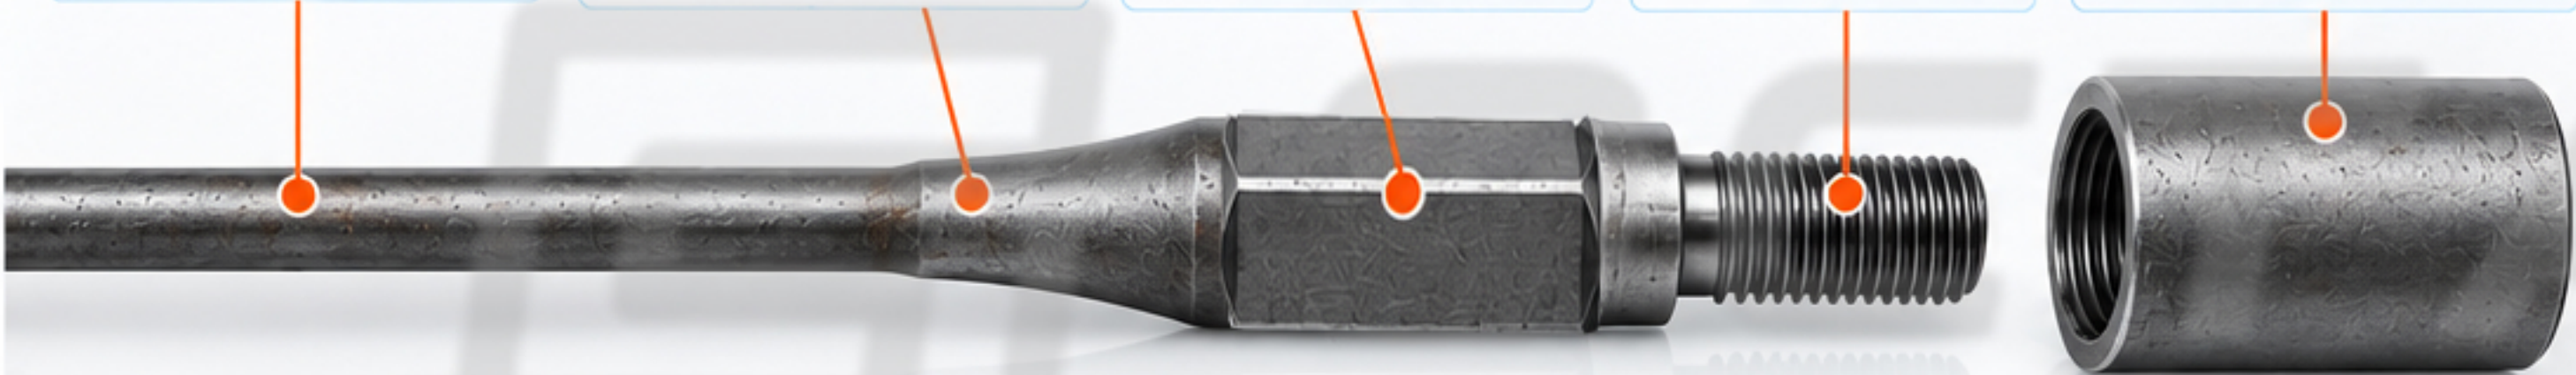
## Sucker Rod Structure and Common Failure Locations

01 Rod Body

- fatigue crack
- corrosion pits
- rod-to-tubing wear

02 Upset Transition

- local cracking
- surface discontinuity
- transition-area stress concentration

03 Shoulder / Wrench Area

- shoulder damage
- impact marks
- make-up related surface damage

04 Pin Thread

- thread wear
- galling
- corrosion
- deformation

05 Coupling

- coupling OD wear
- internal thread damage
- eccentric wear
- cracking

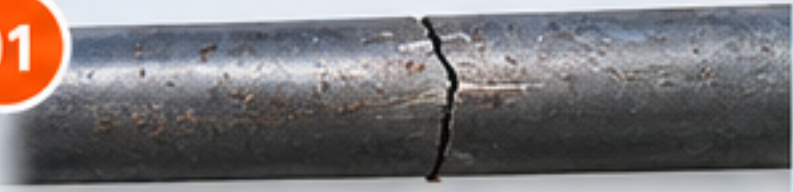
| Observed Condition | Typical Location | Possible Failure Mechanism | What to Check Next |
|---|---|---|---|
| <b>01</b> <b>Transverse / Progressive Rod-Body Crack</b> | Rod body or transition area | Repeated cyclic loading / fatigue | <ul style="list-style-type: none"> <li>Load history</li> <li>rod diameter and grade</li> <li>nearby rods</li> <li>repeated failure depth</li> </ul> |

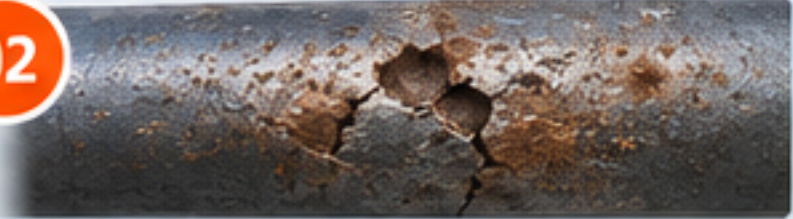
| Observed Condition | Typical Location | Possible Failure Mechanism | What to Check Next |
|---|---|---|---|
| <b>02</b> <b>Crack Starting from Corrosion Pit</b> | Rod body surface | Corrosion-assisted fatigue | <ul style="list-style-type: none"> <li>Produced fluid condition</li> <li>pitting distribution</li> <li>corrosion protection</li> <li>adjacent rod surfaces</li> </ul> |

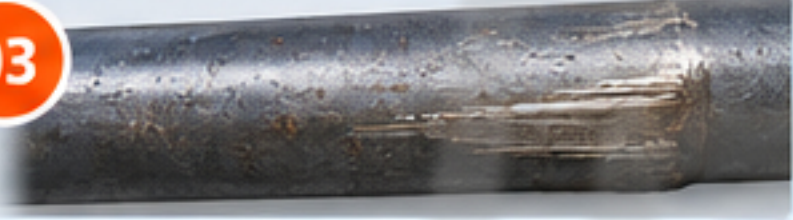
| Observed Condition | Typical Location | Possible Failure Mechanism | What to Check Next |
|---|---|---|---|
| <b>03</b> <b>Localized One-Side Wear</b> | Rod body or coupling OD | Rod-to-tubing contact | <ul style="list-style-type: none"> <li>Well deviation</li> <li>tubing ID</li> <li>rod guides</li> <li>coupling clearance</li> </ul> |

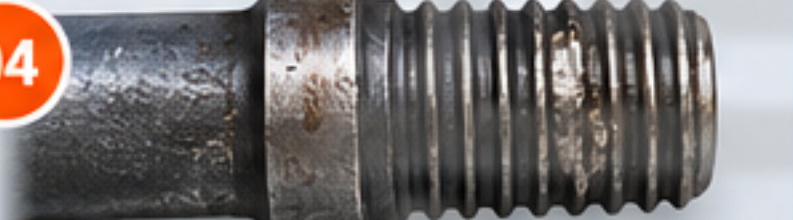
| Observed Condition | Typical Location | Possible Failure Mechanism | What to Check Next |
|---|---|---|---|
| <b>04</b> <b>Damaged / Deformed Threads</b> | Pin or coupling | Connection wear, damaged thread engagement or improper make-up condition | <ul style="list-style-type: none"> <li>Mating thread</li> <li>shoulder contact</li> <li>coupling condition</li> <li>repeated connection failures</li> </ul> |

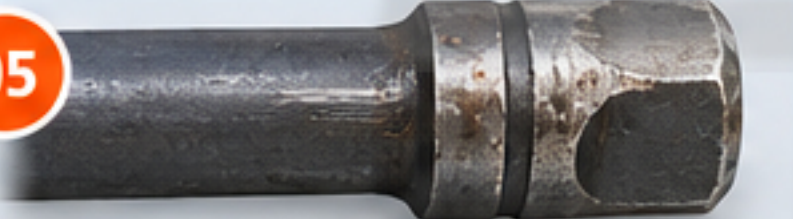
| Observed Condition | Typical Location | Possible Failure Mechanism | What to Check Next |
|---|---|---|---|
| <b>05</b> <b>Shoulder Damage</b> | Rod end | Connection make-up or alignment issue | <ul style="list-style-type: none"> <li>Mating shoulder</li> <li>thread condition</li> <li>rod-end alignment</li> <li>coupling condition</li> </ul> |

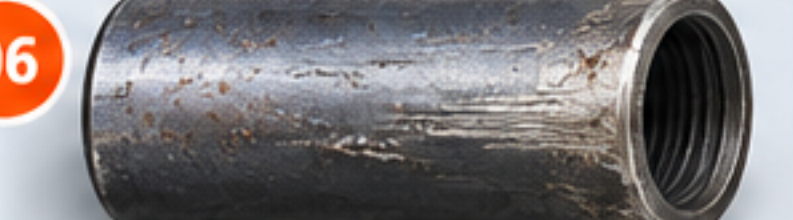
| Observed Condition | Typical Location | Possible Failure Mechanism | What to Check Next |
|---|---|---|---|
| <b>06</b> <b>Coupling OD Wear</b> | Outer coupling surface | Tubing contact / insufficient operating clearance | <ul style="list-style-type: none"> <li>Tubing ID</li> <li>well deviation</li> <li>guide placement</li> <li>wear pattern around circumference</li> </ul> |

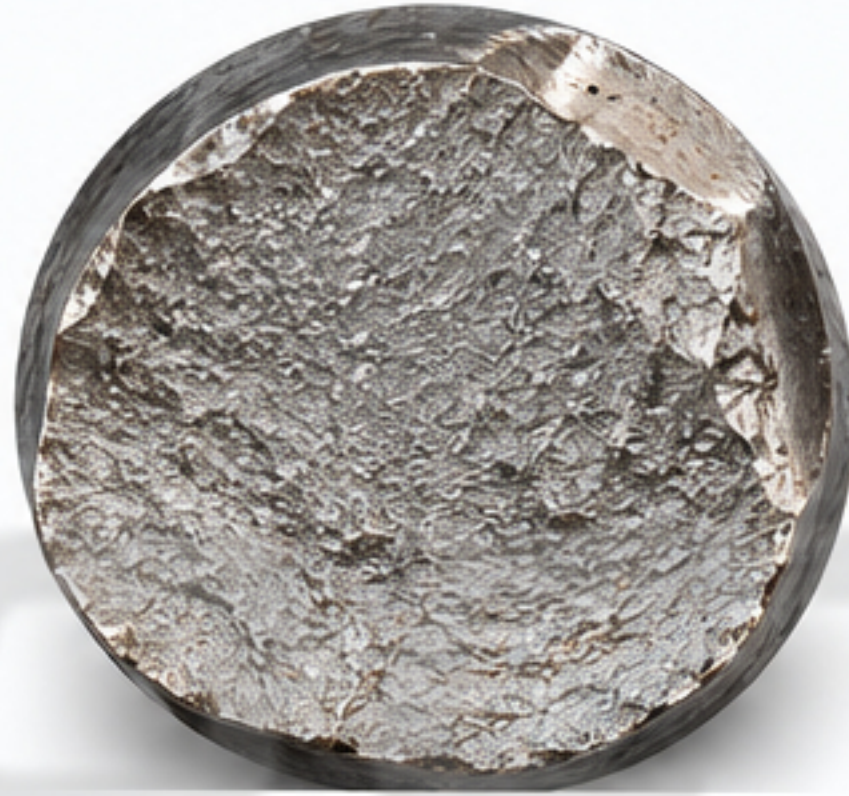
### Overload

#### Typical appearance

- large final fracture region
- possible gross deformation depending on material and loading
- little evidence of progressive crack propagation

#### Check

- abnormal load event
- stuck pump or mechanical obstruction
- unexpected tensile demand
- remaining rod-string condition

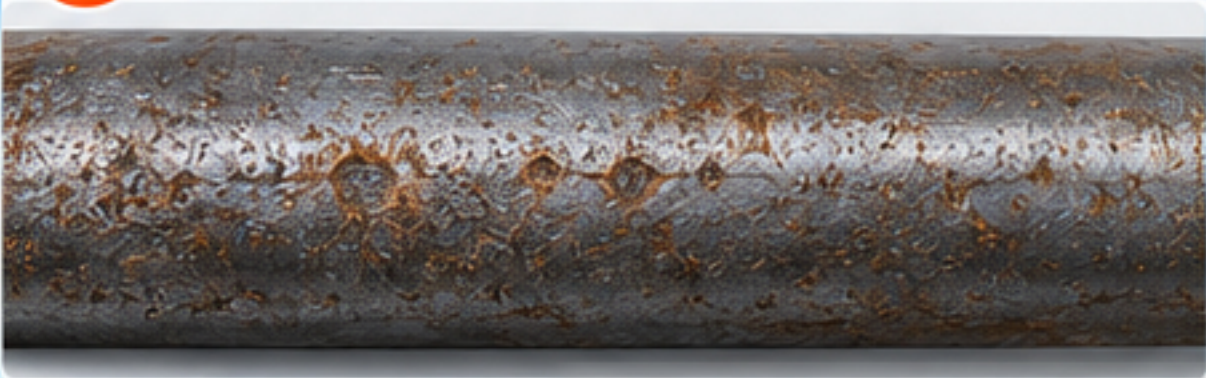
01 General Surface Corrosion

- extent of surface loss
- distribution along rod
- produced-fluid condition

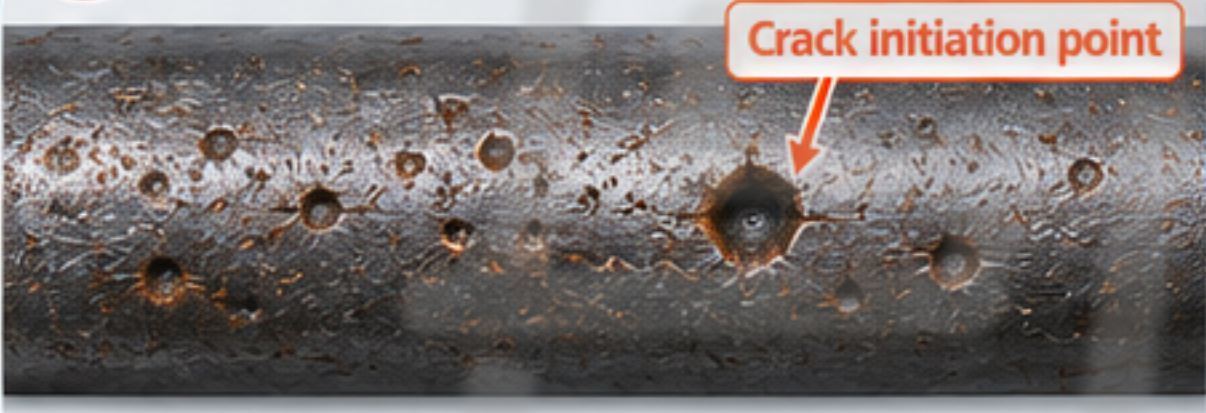
02 Localized Pitting

- pit depth and concentration
- crack indication
- repeated damage at similar depth

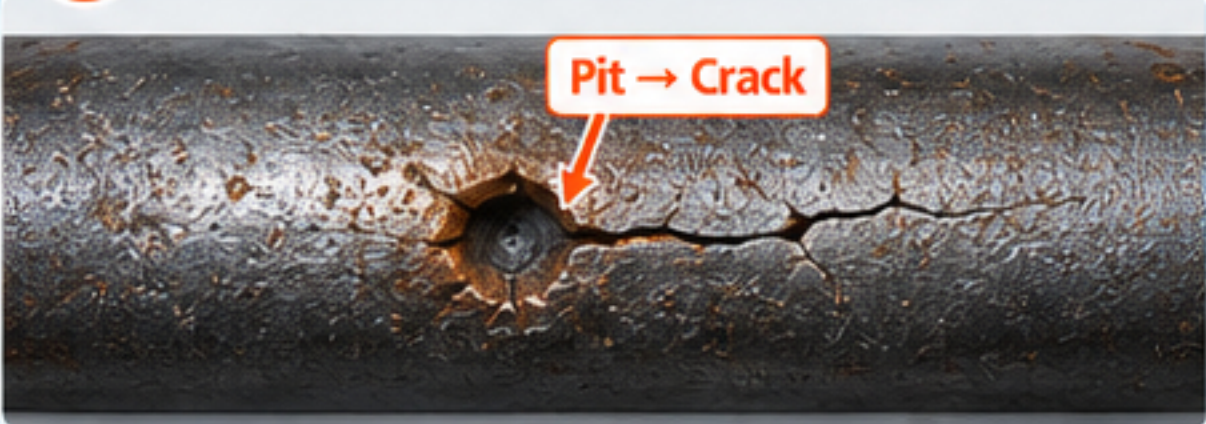
03 Corrosion + Cyclic Cracking

- corrosion location
- cyclic load demand
- grade/material suitability
- adjacent rod condition

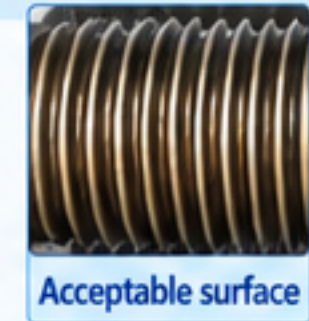
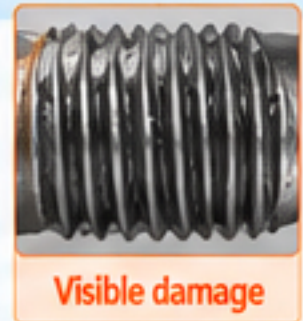
#### 01 Pin Inspection

- thread deformation
- galling
- corrosion
- damaged thread crest/flank
- localized cracking

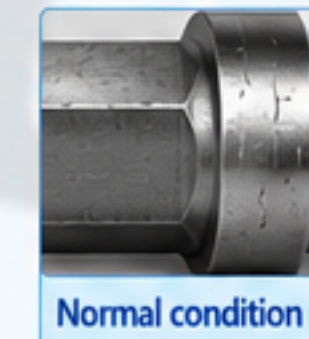
#### 02 Shoulder and Rod-End Inspection

- shoulder contact condition
- impact damage
- wrench-flat damage
- upset-transition cracking
- alignment / bending indication

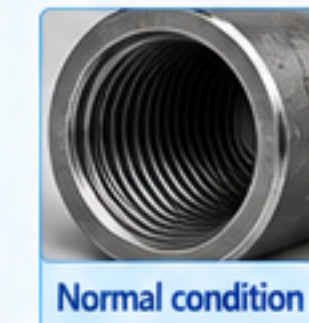
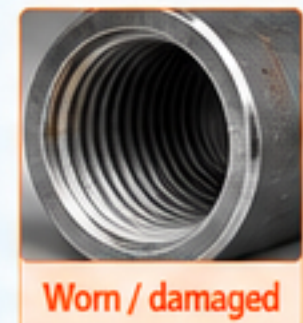
#### 03 Coupling Inspection

- internal thread condition
- outside diameter wear
- eccentric wear
- corrosion
- cracking
- compatibility with mating rod pin

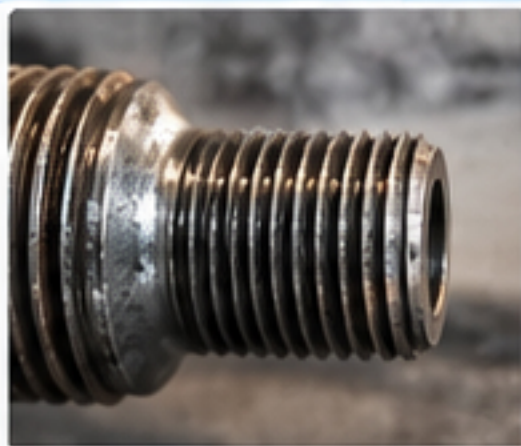
01 Pin Inspection

- thread deformation
- galling
- corrosion
- damaged thread crest/flank
- localized cracking

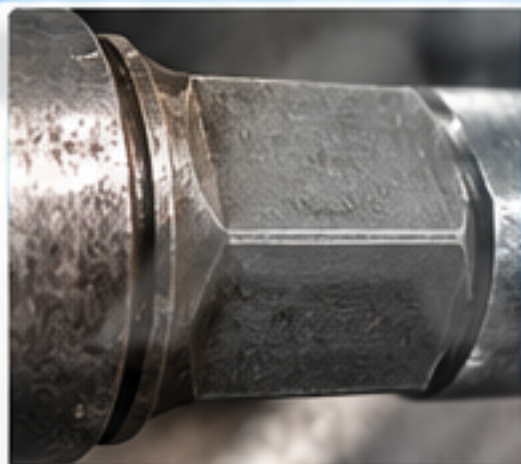
02 Shoulder and Rod-End Inspection

- shoulder contact condition
- impact damage
- wrench-flat damage
- upset-transition cracking
- alignment / bending indication
